LETTER REPORT  
FOR  
SANDOVAL ZINC  
SANDOVAL, MARION COUNTY, ILLINOIS  
TDD: T05-9111-010  
PAN: EIL0760DAA

MARCH 13, 1992

RE: Sandoval Zinc site  
Sandoval, Marion County, Illinois  
TDD # T05-9110-025  
PAN # EIL0760DAA

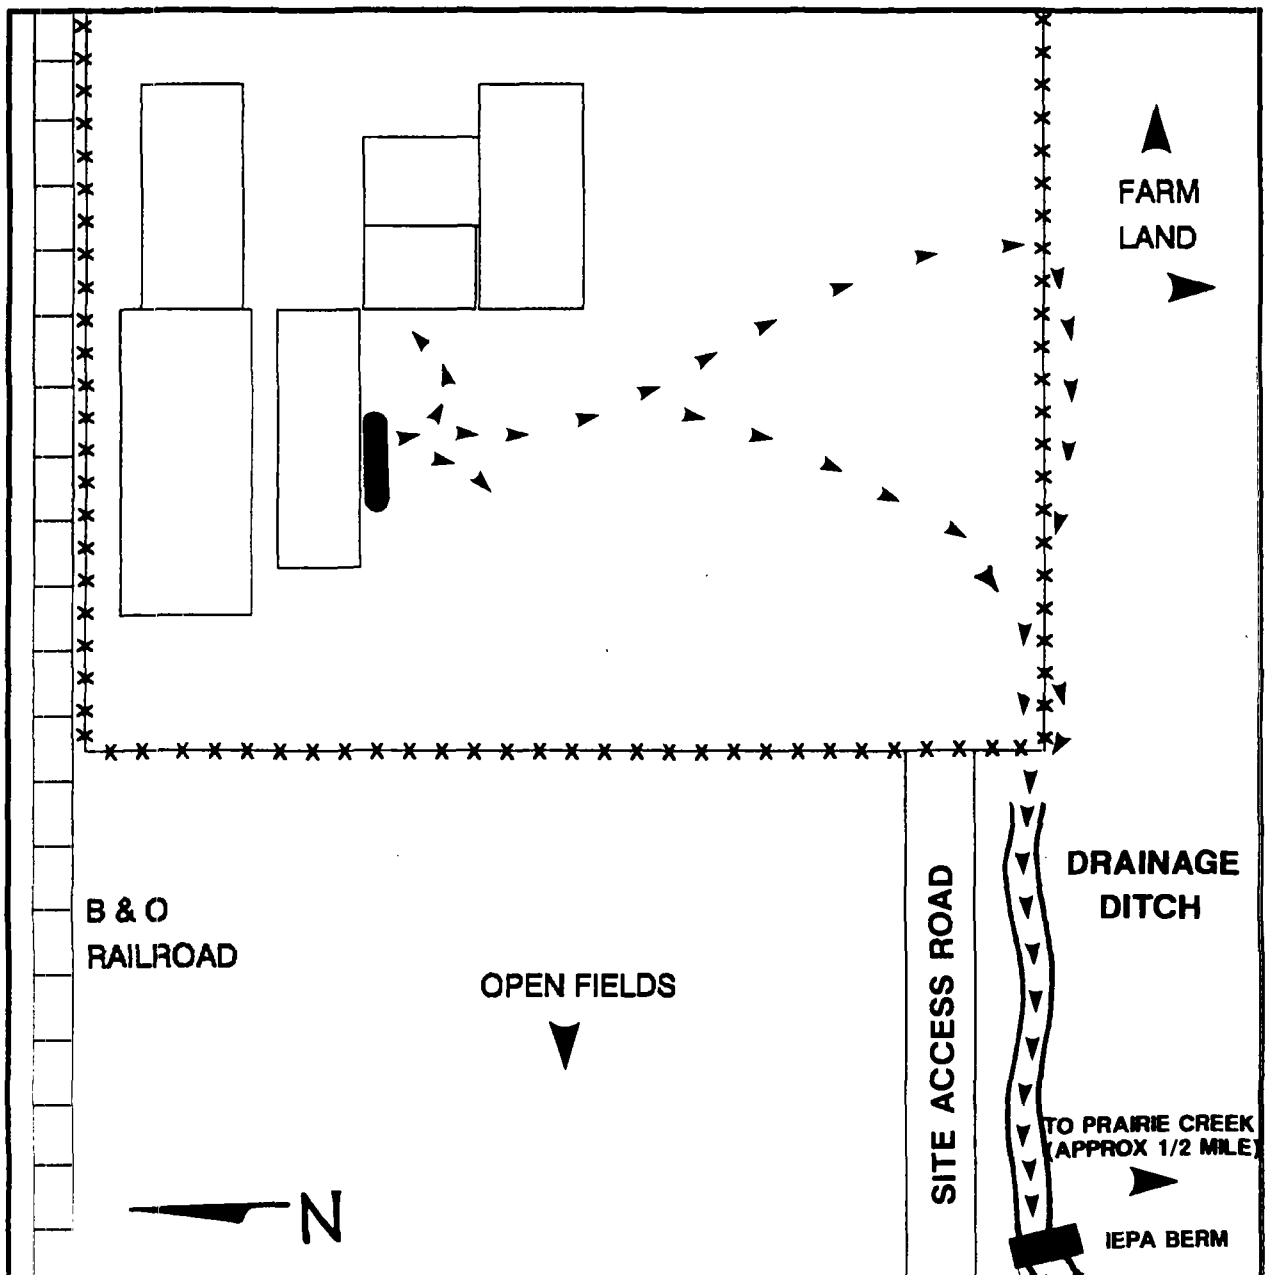
had minimized further migration. Figure 3 depicts the migration pathway of the spill. IEPA believed that the product in the tank was probably pure, but the spilled oil may have possibly acquired some of the heavy metal contaminants as it ran across the site. The OSC and TAT agreed to sample the oil and have it analyzed for heavy metal concentration. IEPA also confirmed, via their Superfund office, that no viable Potentially Responsible Party (PRP) existed for the SZ site.

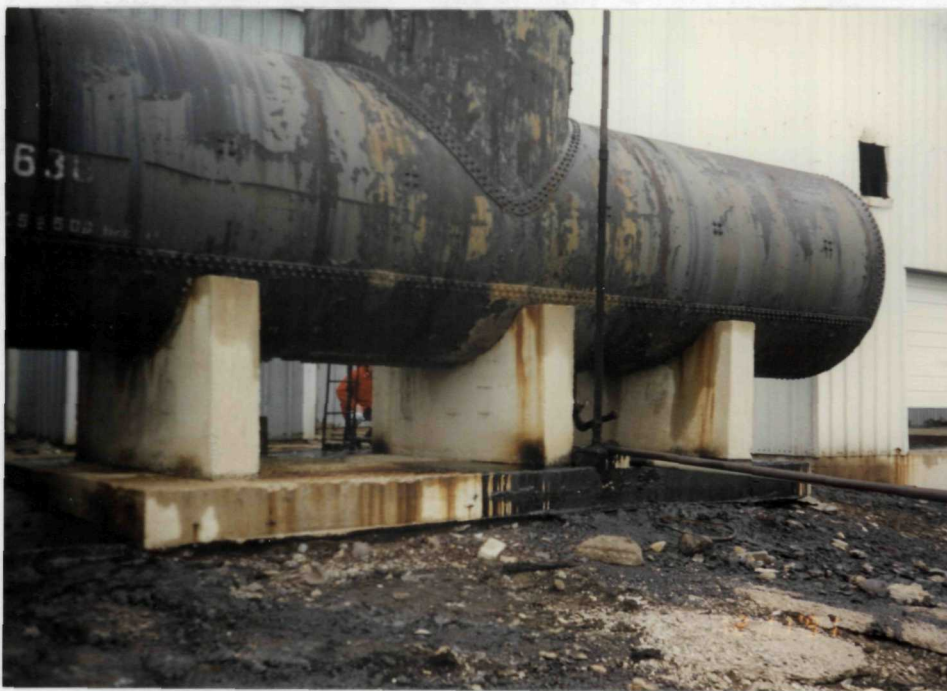
DESCRIPTION: View of on-site storage tank -- source of spill.

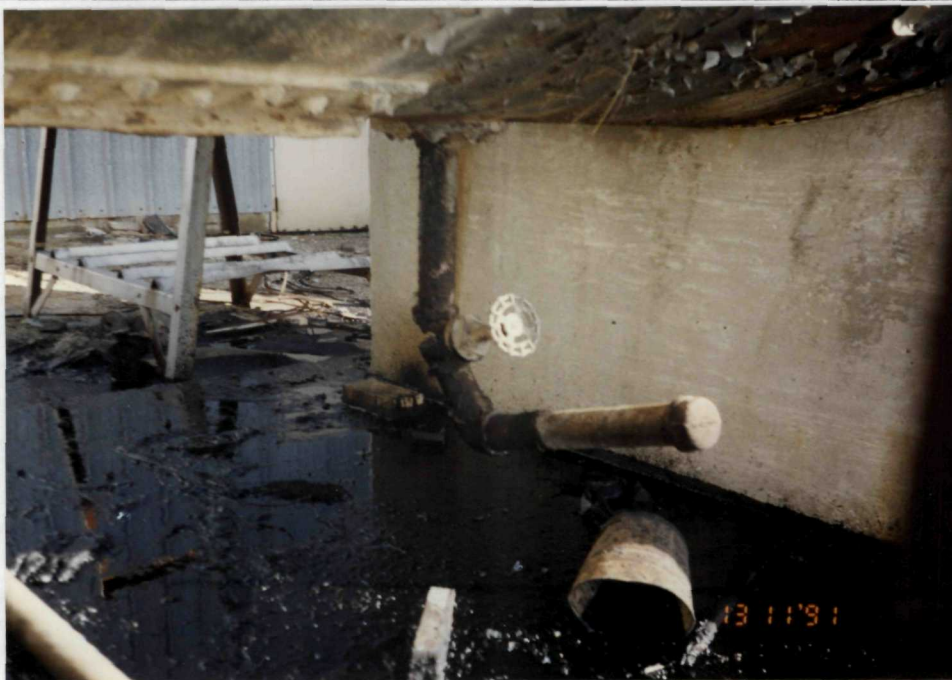
On Sunday, November 10, 1991, the Sandoval Police Department contacted the IEPA to report a diesel spill at the site. A pipe at the base of the 11,000 gallon aboveground storage tank (abandoned

railroad car) had either frozen and ruptured or been vandalized. An undetermined quantity of #5 diesel fuel oil had been released to the site, and had migrated into the drainage ditch that runs along the south side of the site access road. IEPA personnel from the Collinsville Division had responded to the emergency and constructed a berm across the drainage ditch in the area where it turned south. This berm, along with absorbent boom placed at the edge of the spill, prevented the oil from reaching Prairie Creek. IEPA then requested U.S. EPA assistance and Oil Pollution Act (OPA) funding for the emergency response clean-up.

DESCRIPTION: View of ruptured pipe valve that resulted in spill.

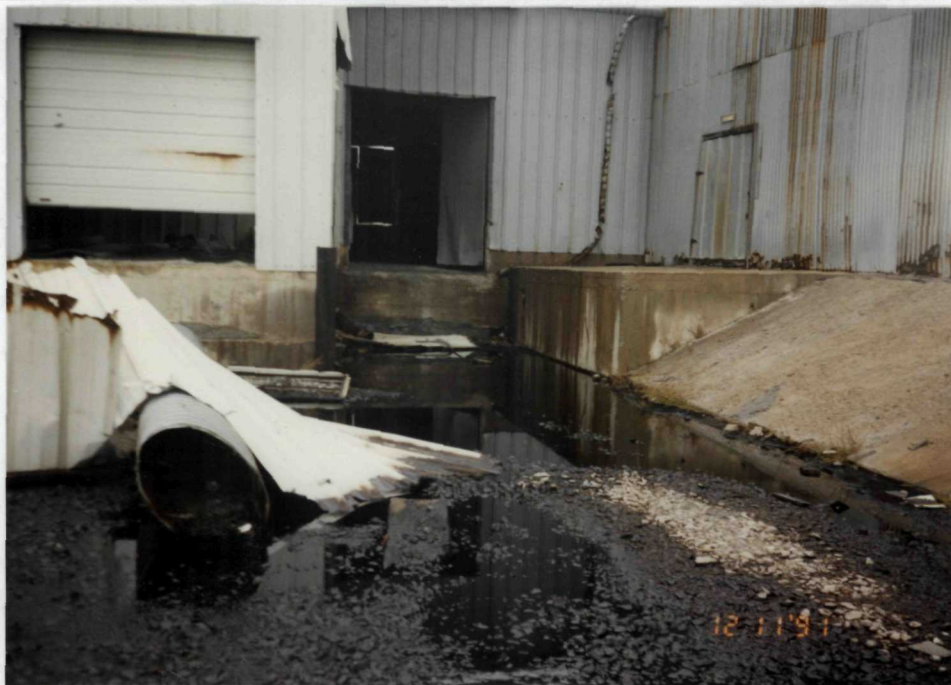
DESCRIPTION: View of pooled oil east of source. Oil sample #1 was collected from loading dock area in background.

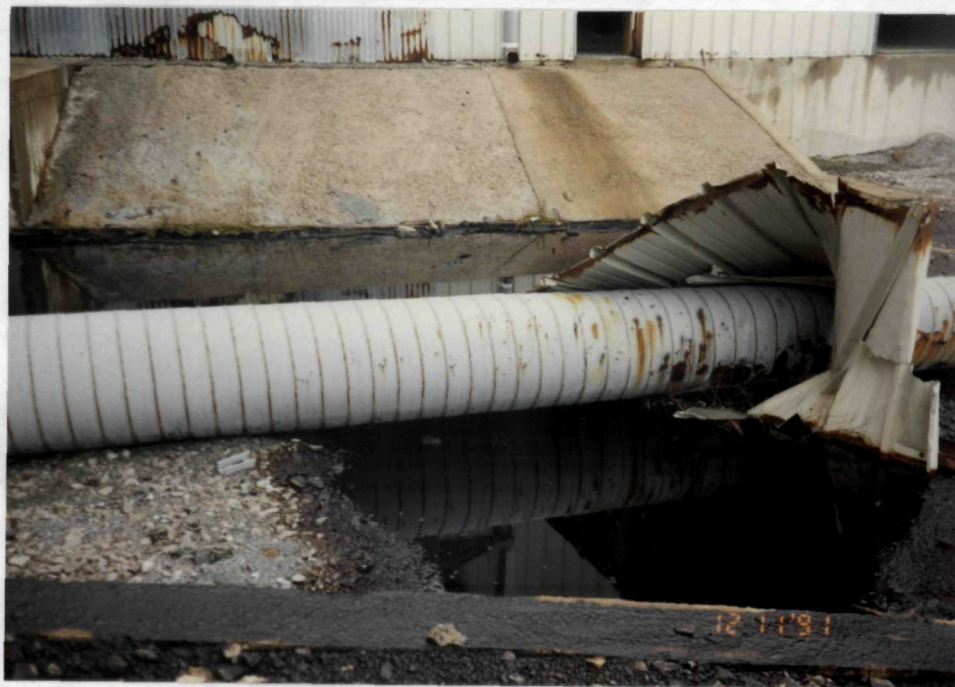
DESCRIPTION: View of pooled oil to east of tank.

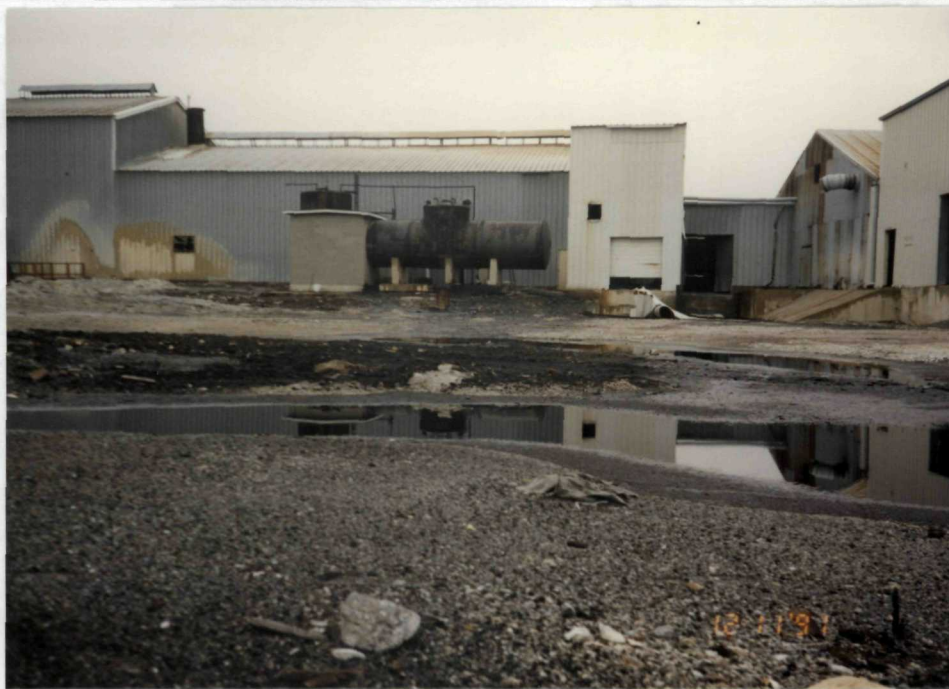
DESCRIPTION: View of pooled oil spread across facility yard.

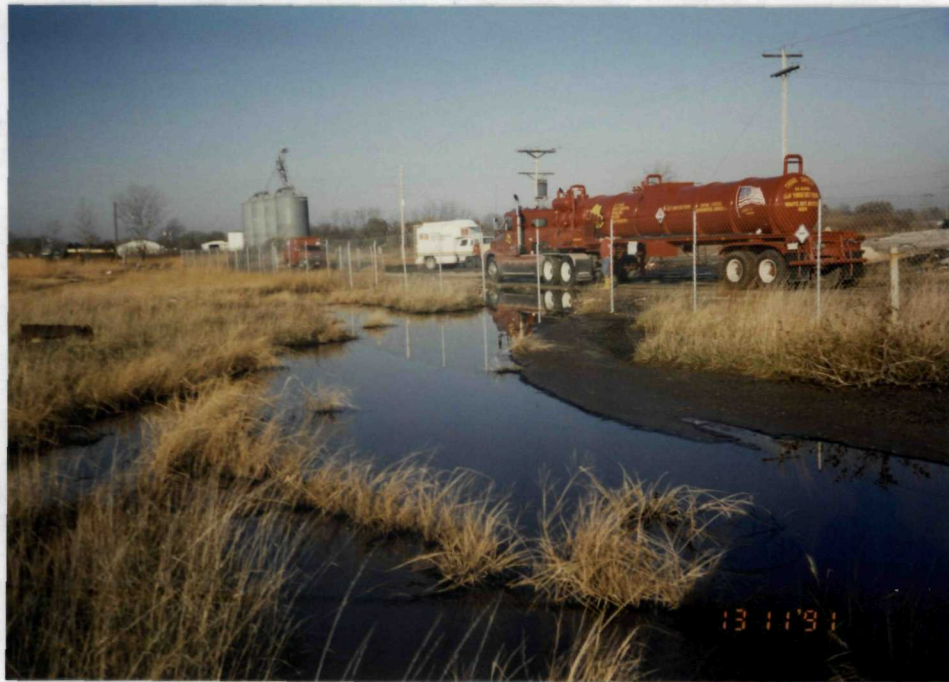
DESCRIPTION: View of pooled oil south of the facility boundary. Spill continued to the west via a drainage ditch.

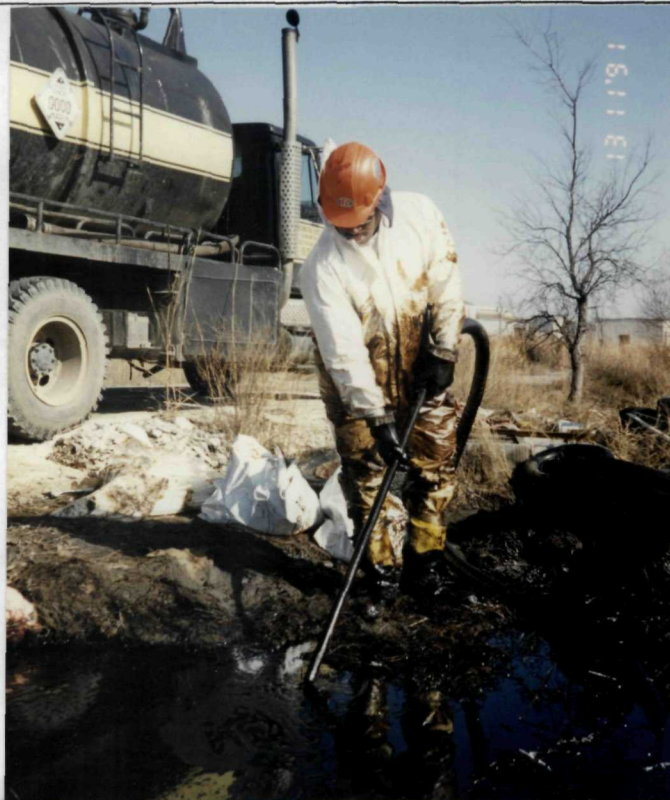
DESCRIPTION: Vacuum operations

in drainage ditch along site

access road. This area is

approx. 40 feet from tailend

of the spill.

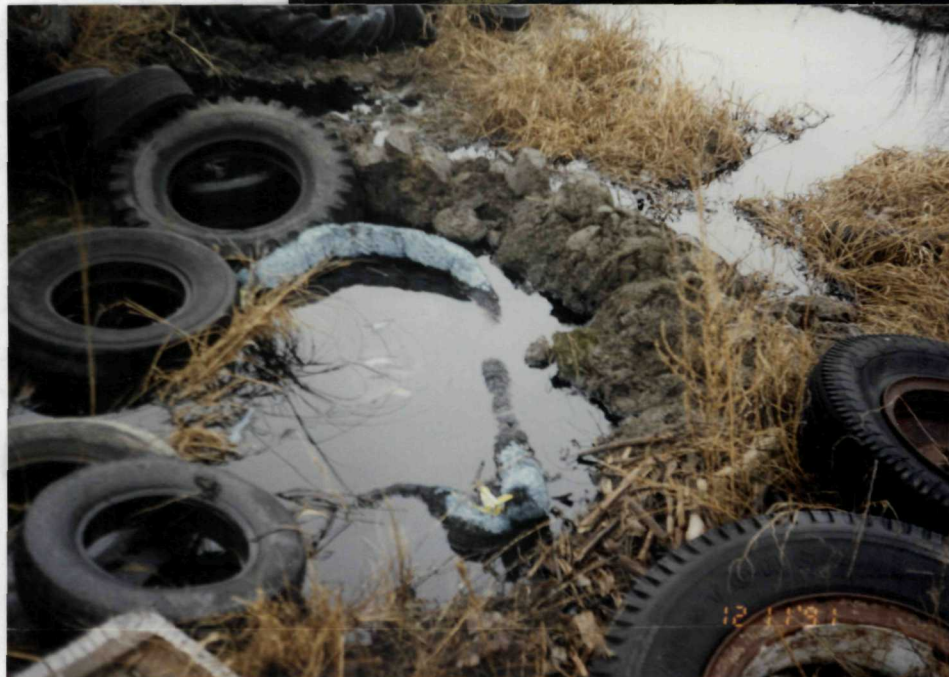
DESCRIPTION: View of berm and boom built by IEPA responders. This action  
prevented the migration of the spill to the nearby Prairie Creek.

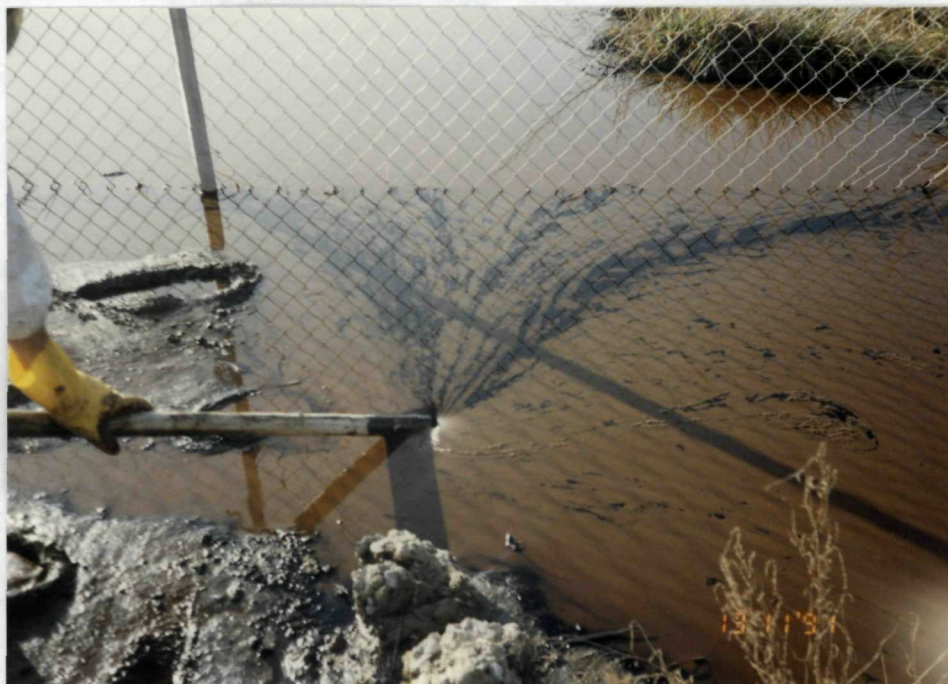
DESCRIPTION: Vacuum operations inside facility yard. Note large pool outside of facility boundary (fenceline).

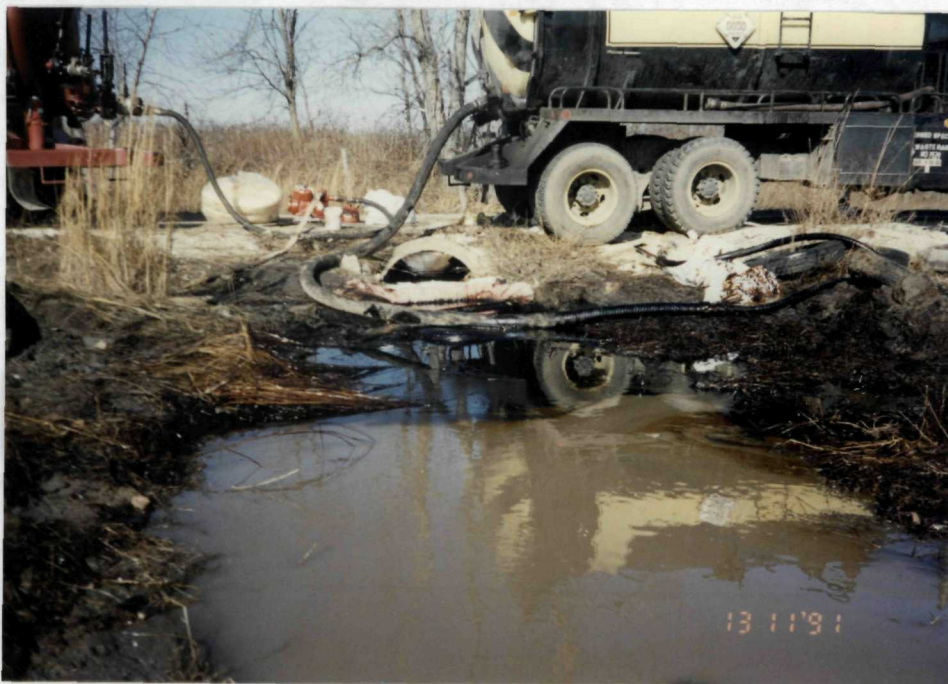
DESCRIPTION: Progress view of cleanup activities in culvert area near tailend of spill.

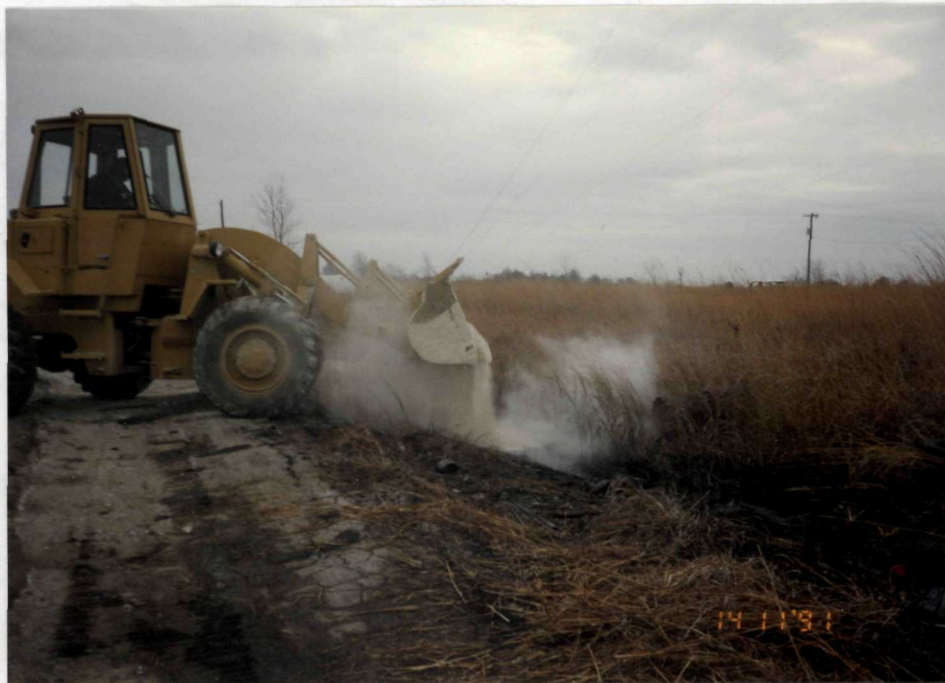
DESCRIPTION: View of kiln dust being spread on oil-saturated soils in ditch.

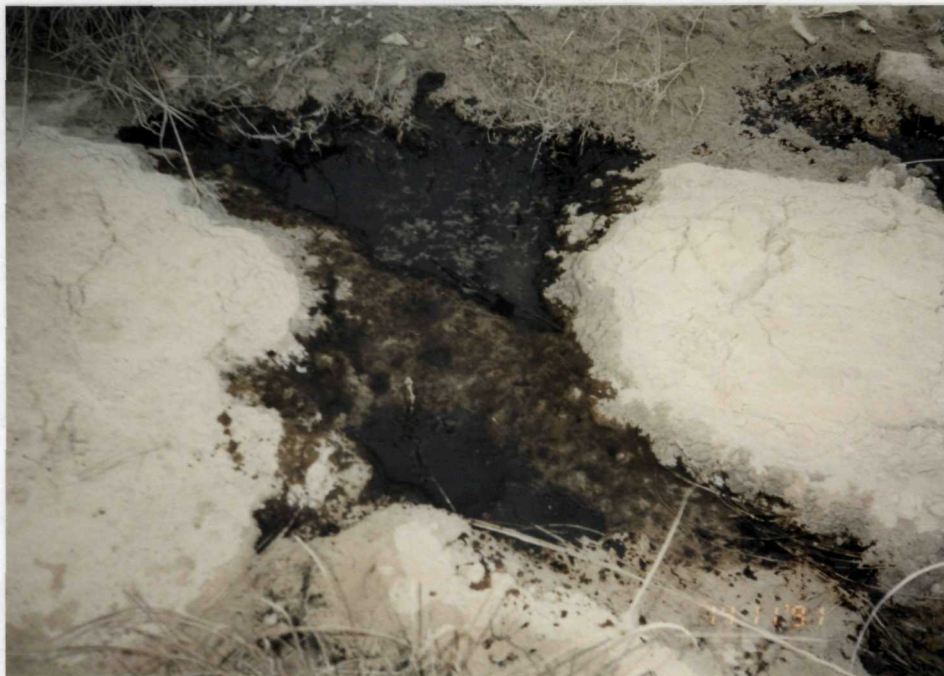
DESCRIPTION: View of kiln dust absorbing remaining oil after vac operations.

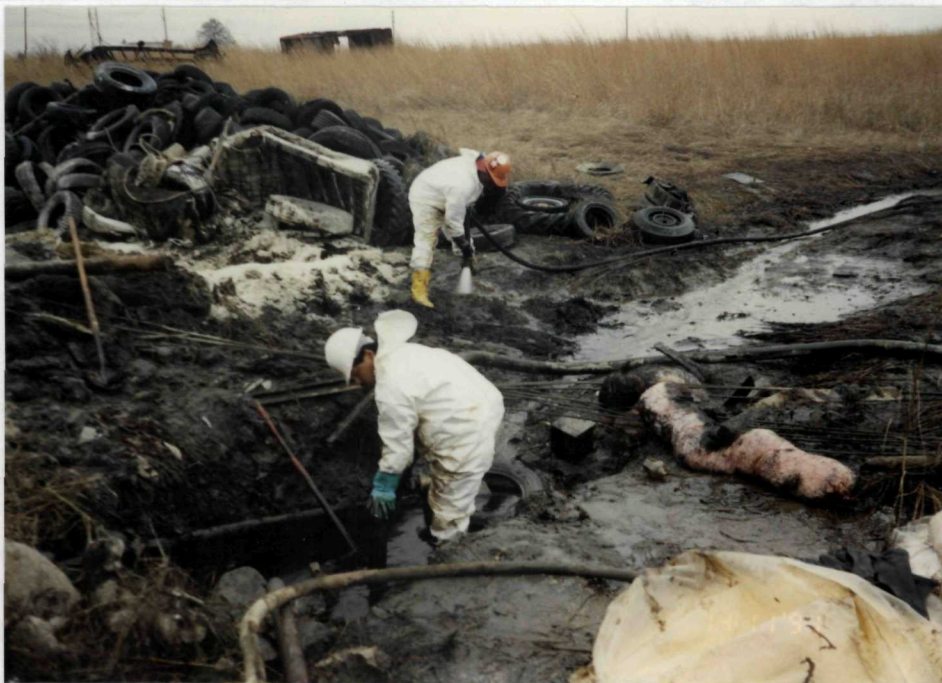
DESCRIPTION: View of oil being flushed towards pump placed in culvert.

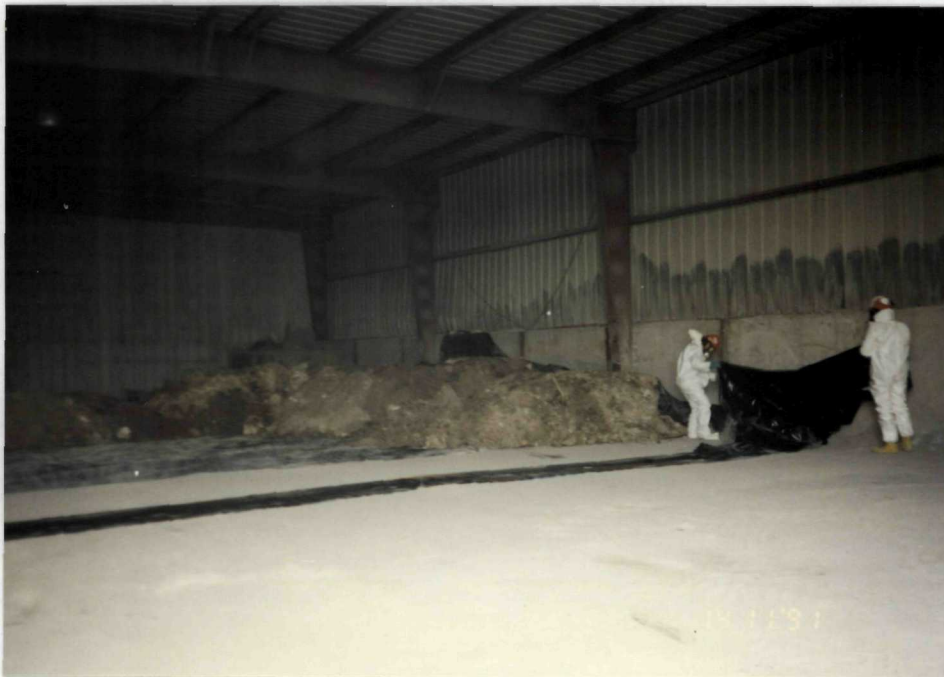
DESCRIPTION: View of crew preparing building for additional storage of excavated soils.

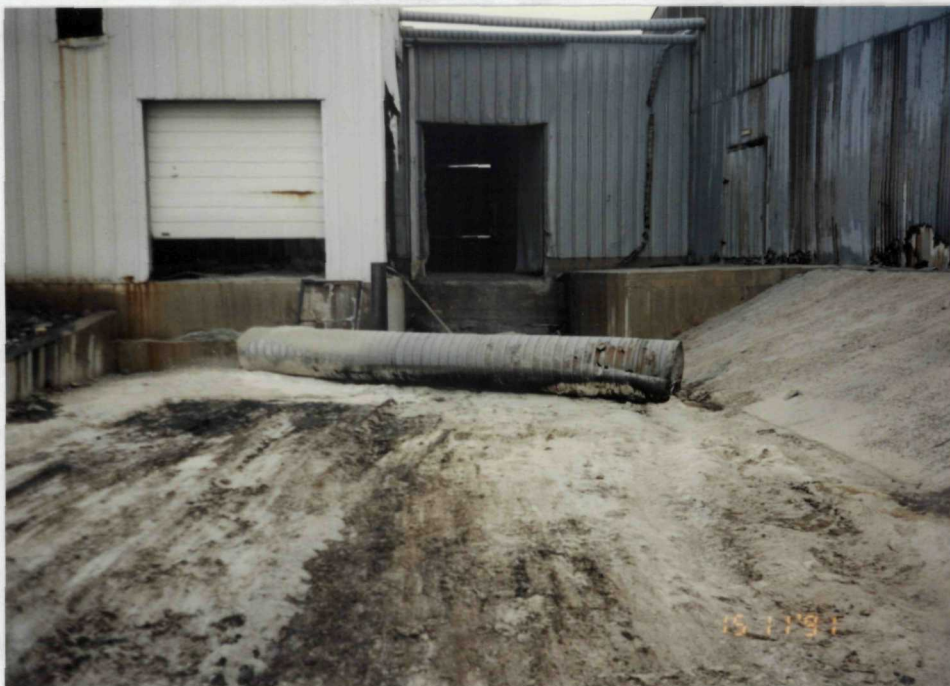
DESCRIPTION: View of facility yard after oil saturated kiln scraped off.

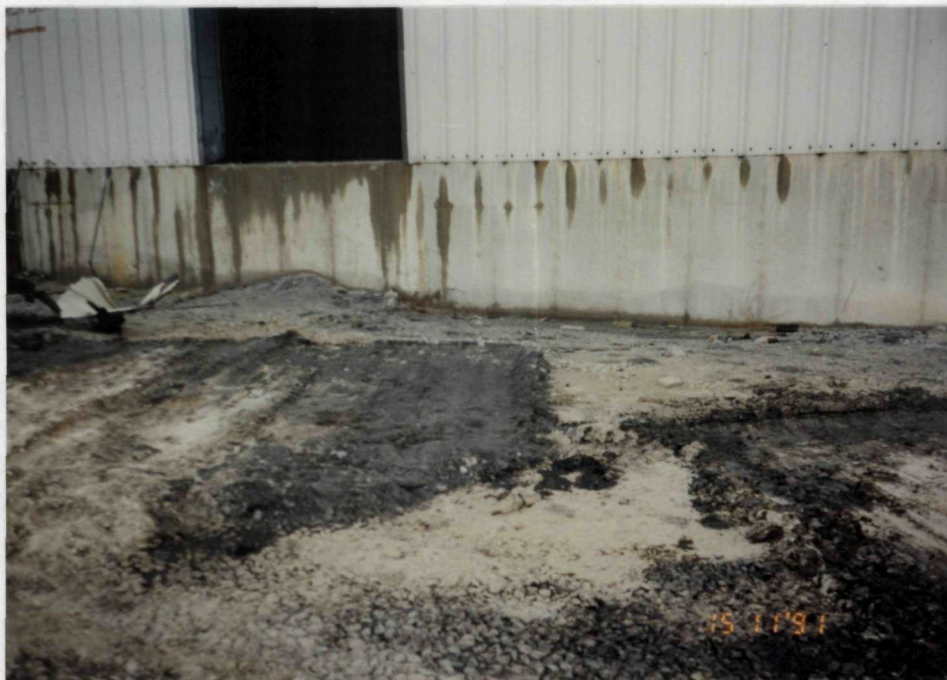
DESCRIPTION: View of facility yard after oil saturated kiln scraped off.

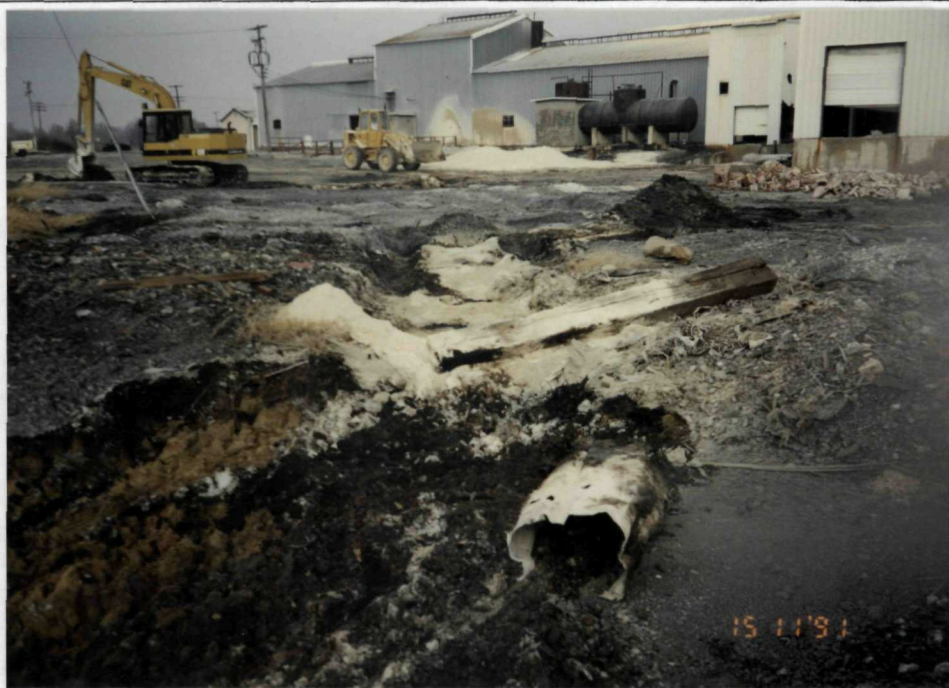
DESCRIPTION: View of kiln being spread and scraped in facility yard.

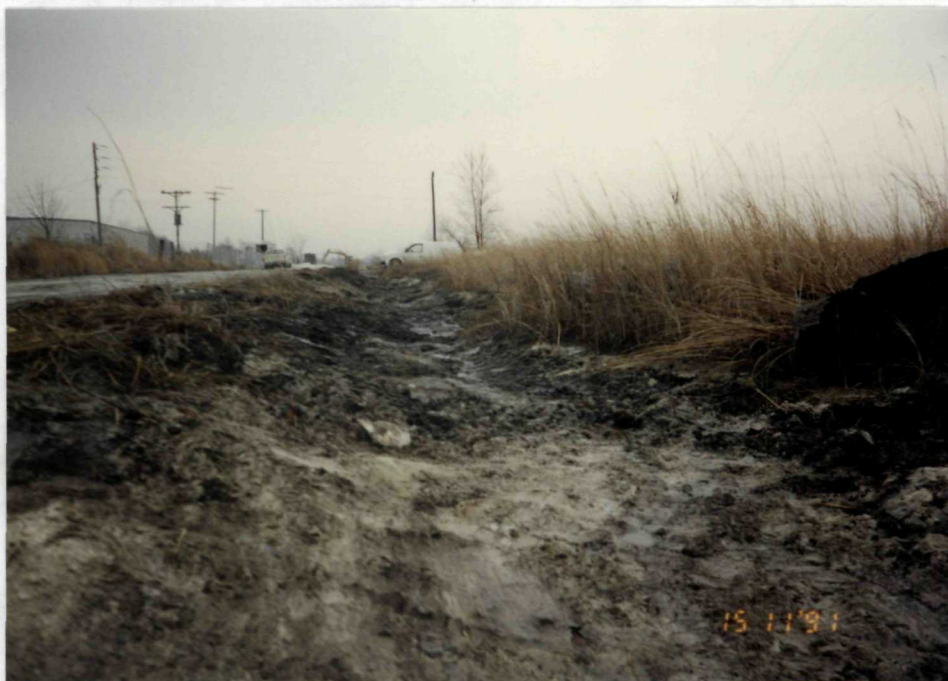
DESCRIPTION: View of cleaned ditch after soil/kiln mixture excavation.

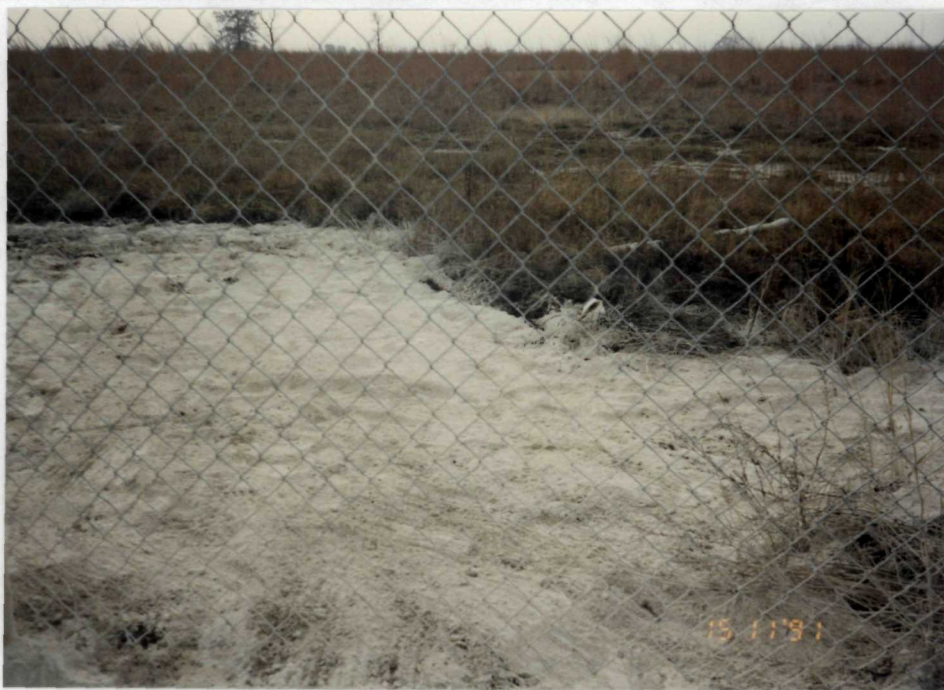
DESCRIPTION: View of kiln left on large pool of oil outside facility boundary.

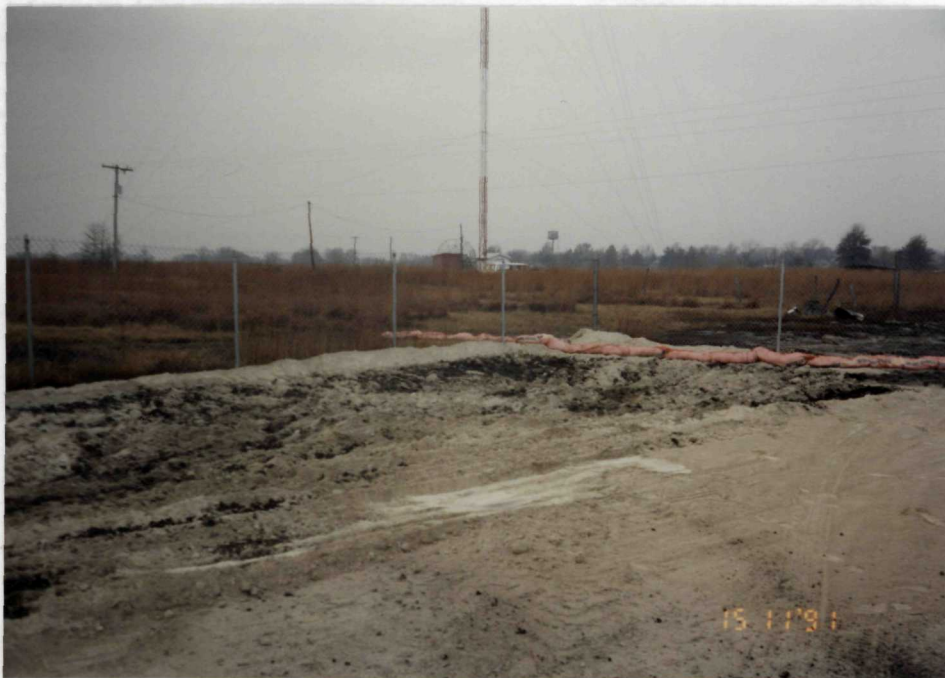
DESCRIPTION: View of scraped SW corner of facility. Booms were left in place to prevent any possible runoff after anticipated rains.
